Case Study: Solving a Difficult Military Beam Alignment Task

Dick Rieley, East Coast Regional Sales Manager, Ophir Photonics Group

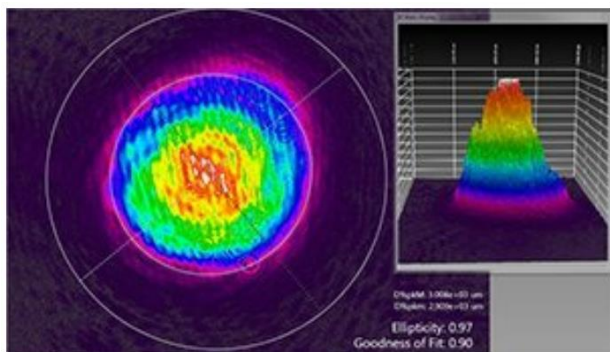
Figure 1. 2D & 3D Beam Profiles of Laser's Raw Beam Ellipticity:
97% | Gaussian Goodness of Fit: 90%

Three key measurements were made: 1) a baseline measurement of the source beam using the 1/e2 measurement value, 2) a measurement calculation of the beam's ellipticity (roundness), and 3) a calculation as to the laser source's Gaussian, or Goodness of Fit value.

The first beam analysis was conducted on the raw beam from the laser source to establish a baseline of the size and shape of the beam, the orientation of the beam (round or oval), and, if oval, the direction of the minor and major axis positions. Due to the critical nature of the quality of the laser source, having a beam that possesses an ellipticity value of 92% or better is essential (a perfectly round beam has an ellipticity of 100%). Most high quality laser sources demonstrate an ellipticity value of 90% or better. In most high reliability applications, any measurement that is within 10% of an absolutely perfectly round beam meets specification.

The beam size, measured using the 1/e2 (13.5% of Peak) technique as specified by the manufacturer of the source, was validated by the BeamGage measurement when imaged at a short distance from the source. The overall shape of the beam and the distribution of the intensity internal to the beam was another issue that had yet to be diagnosed.

Once the overall beam size had been validated and determined to be within specification, the next analysis required the measurement of the ellipticity (or roundness) of the beam. BeamGage Professional software offers this quantitative measurement and graphic validation of this condition by activating the ellipticity measurement, which is a ratio of the major and minor axes. The quantitative measurement of ellipticity was determined to be 97%. Figure 1 shows the major crosshair (from lower left to upper right) and the minor crosshair (from lower right to upper left). The actual difference in

the beam diameter measurement vs the same measurement when the ellipticity measurement is activated is only a difference of 197 μ m.

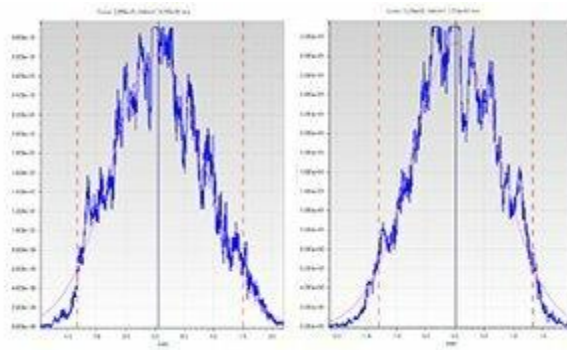
was to obtain both the quantitative value for Gaussian Fit (Goodness of Fit) as well as obtain a graphic representation of the actual measurement of the laser source. In this case, the goodness of fit was calculated to be 0.90, which is a value most applications would accept. However, in high reliability applications such as this one, the 0.90 may not be sufficient – but that had yet to be determined. The important result of this measurement is that it allows engineering to make adjustments to the beam based on quantitative results, not based on an interpretation or opinion of an image.

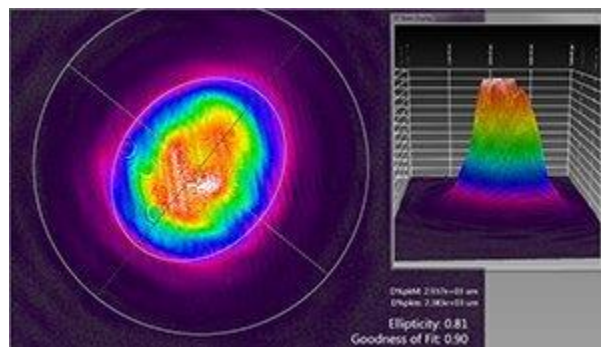
At this intermediate position, change had occurred; the beam size had increased by 5%, which means that the beam had some divergence present. Also, the ellipticity had deteriorated by 16% while the goodness of fit remained largely unchanged.

The important aspect of these measurements for this application and the technical staff involved in qualifying the laser source is the opportunity to not only see the graphical difference from beam profiling at different distances from the source, but, more importantly, to capture the quantitative differences. These values allow for adjustment and improved efforts on the source. They also determine, by the numbers, the impact on the over project. Only through the use of the beam profiling software were the engineers able to capture these key measurements and images. With them, the technical staff can begin to identify the variables within the laser source and its final assembly to ensure the overall performance of this complex system meets the rigorous specification of the application.
